NATIONAL TRANSPORTATION SAFETY BOARD

Fire & Explosion Group Factual

Accident Number: DCA06MF016
Operator: Massachusetts Baylines
Location: Boston Harbor
Date: June 12, 2006
Time: Approximately 4:15 pm
Vessel ID #: 927011

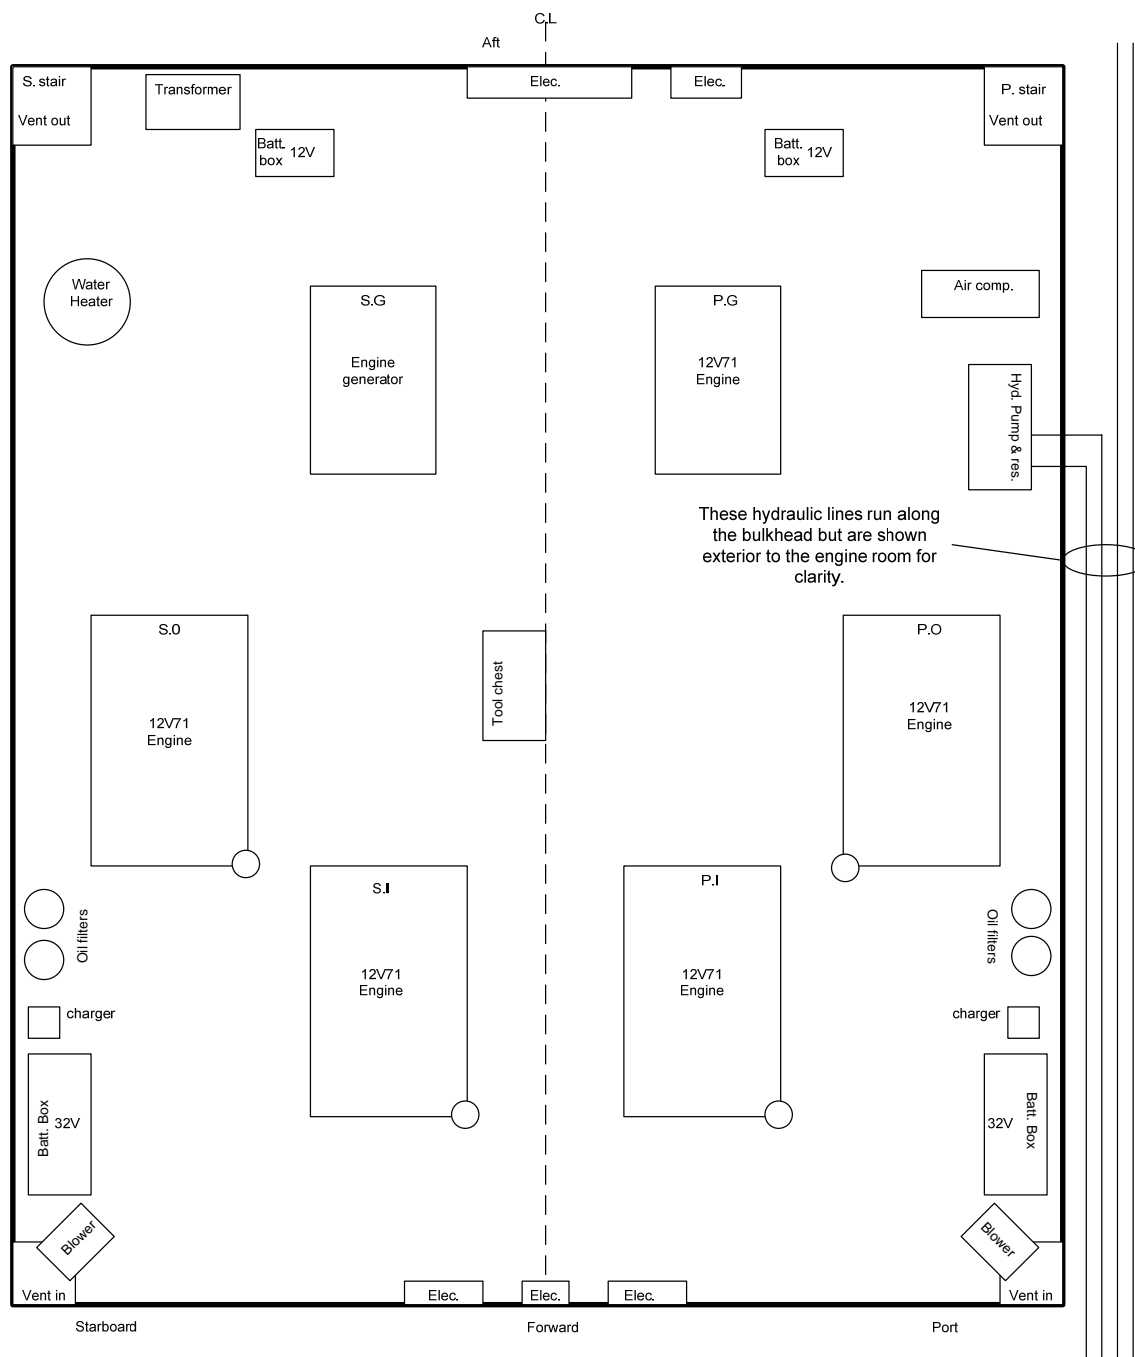
Figure 3: Sketch of engine room layout. (Not to scale)

A diagram depicting the layout of the engine room can be seen in Figure 3. The engine room contained four 12v71 series Detroit diesel engines for propulsion. Each engine had a turbo on each of its sides. There were also two 30kW, 3V71 series Detroit diesel generators, four battery banks and associated electrical control panels and a transformer located within. The hydraulic pumps and reservoir for the steering system were also located in the engine room. Additionally there was a water heater and air compressor located in the engine room. There was a main fuel distribution system delivering fuel from the two tanks to the four engines and two engine generators. This distribution system was a fixed installation and was made out of steel pipe on the supply side and copper tubing on the return. These fuel lines were all traced and found to be intact with no sign of damage.
